# **Installation Restoration Program**

# PHASE I - RECORDS SEARCH

United States Air Force Academy Colorado Springs, Colorado

December 1984

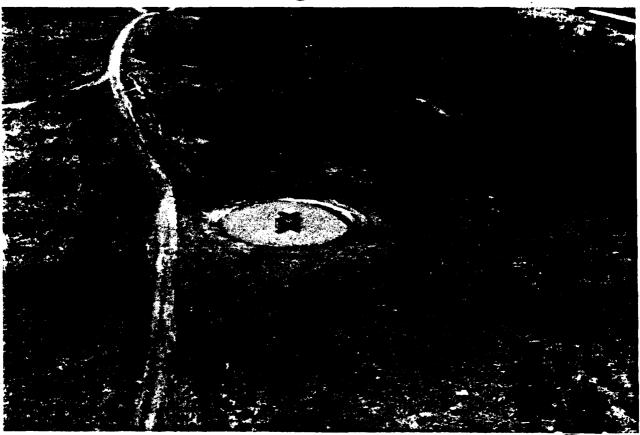
FIGURE 5-4 FIRE TRAINING AREA (VIEW IS FROM A HELICOPTER)

- o Fire Training Area: The Fire Protection Training Area has been identified as a site for additional investigation because the site is in close proximity to a stream and to ground water. The recommendations developed are to sample ground water and the soil between the site and the stream.

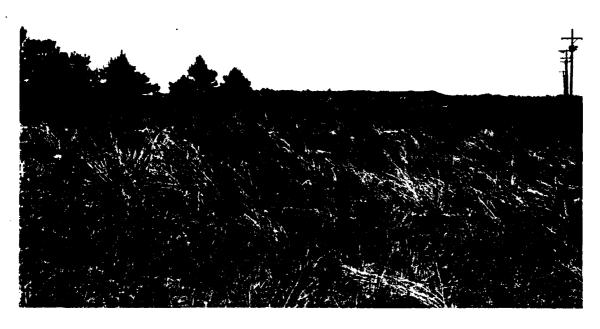
FIGURE 5-6 WORLD WAR II DISPOSAL SITE - LOOKING NORTH FROM VISITORS CENTER

The primary concern for potential environmental contamination from this two-part site results from the practice of using sodium arsenate and potential for concentration of arsenic in the lake sediments to control algae in the lakes at Farish. The dredged material was removed from the lakes
